**THE ROLE OF THE FORENSIC AUTOPSY IN RECONSTRUCTING VEHICLE-PEDESTRIAN IMPACT - A CASE REPORT**

**Abstract**

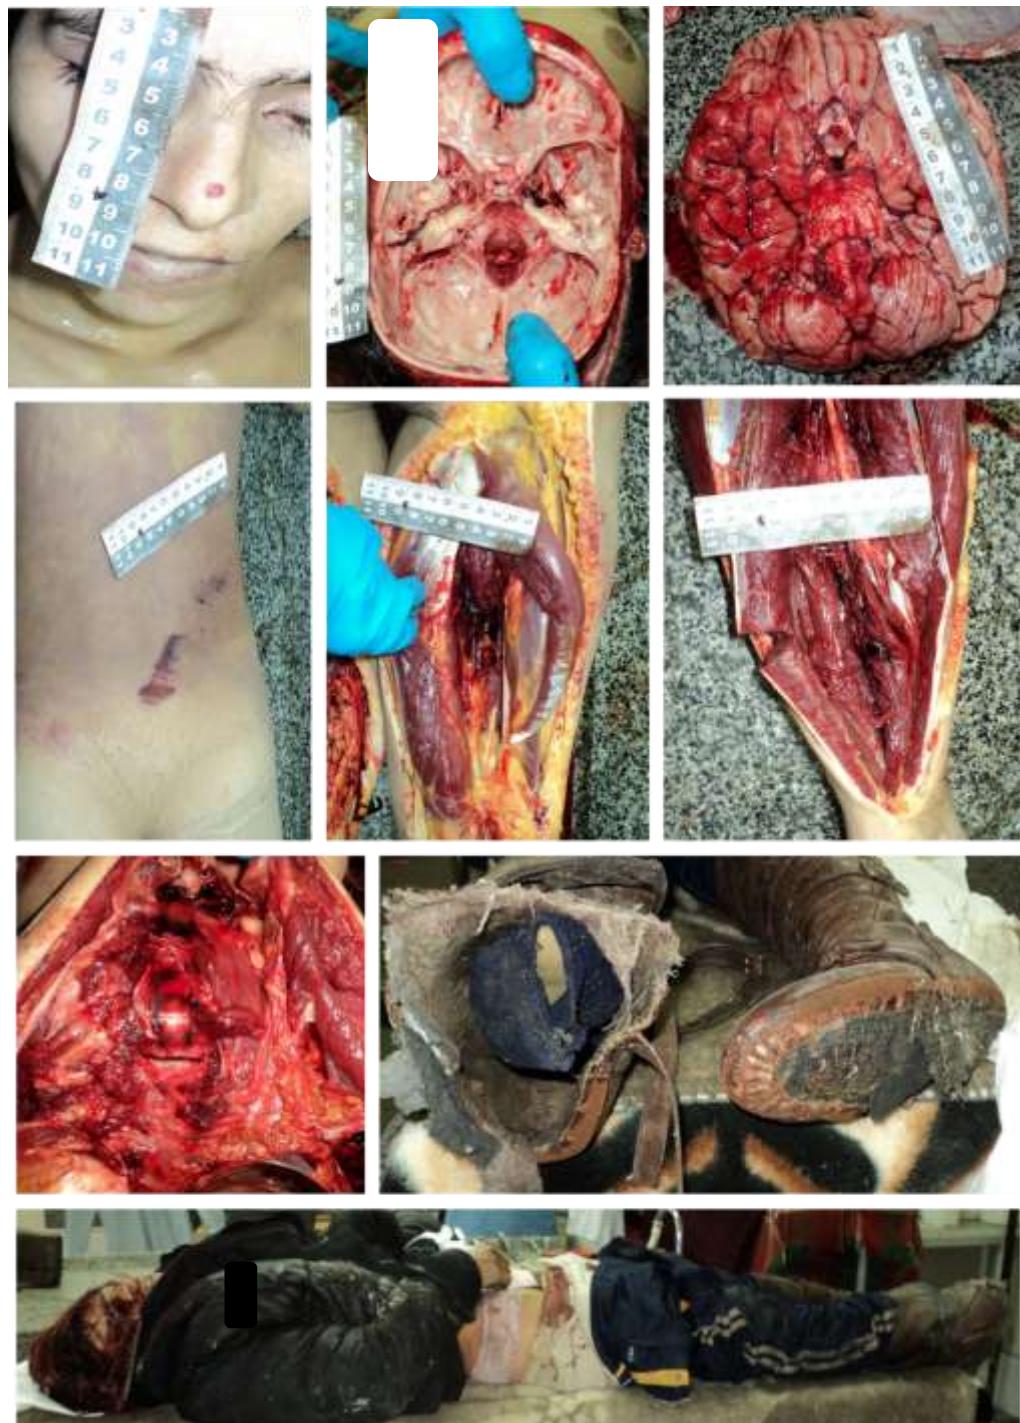
Figure 1. Clothes defect and injuries to the body of the deceased.

During the forensic autopsy of the corpse, as well as after the additional forensic chemical examinations, it was established (Figure 1):

- Closed craniocerebral trauma, expressed in: hemorrhage on the inner surface of the soft cranial cover on the border of the parieto-occipital region of the head on the right, on an area of 4/3 cm; hemorrhage under the meninges (subarachnoid hemorrhage) in the temporal region of the right cerebral hemisphere; hemorrhage under the meninges in the area of the bridge, medulla oblongata on the right, and on the right cerebellar hemisphere on its upper surface; fracture of the base of the skull, with the line passing transversely through the two middle cranial fossae and “sella turcica”.

- Severe cervical trauma: rupture of the intervertebral disc between the second and third cervical vertebrae; rupture of the intervertebral disc between the fifth and sixth cervical vertebrae; opening in these areas of the spine to its anterior surface; hemorrhage of the surrounding soft tissues and the spinal cord;

- Trauma in the lumbar region and lower extremities: linear abrasions and bruising in the right lumbar region; abrasion in the left lumbosacral region; hemorrhage of the deep muscles on the

posterior surface and in the soft tissues of the right thigh, posterior surfaces and deep soft tissues of the left lower leg, on two levels in the upper and lower thirds, and on the right lower leg in the upper-middle third.

- Abrasion on the anterior outer surface of the right ankle, abrasions at the base of the first toe of the right foot and the main phalanx of the same toe; superficial abrasion on the back of the nose in its lower third;
- Lack of ethyl alcohol, drugs and narcotics in the blood and urine of the corpse.
- Presence of a thick layer of clothing on the body, lack of the sole of the left boot, without stains on the base of the foot; Rupture and partial absence of the front part and the sole of the right boot, with a tear on the bottom of the right sock in the area of the toe pads.

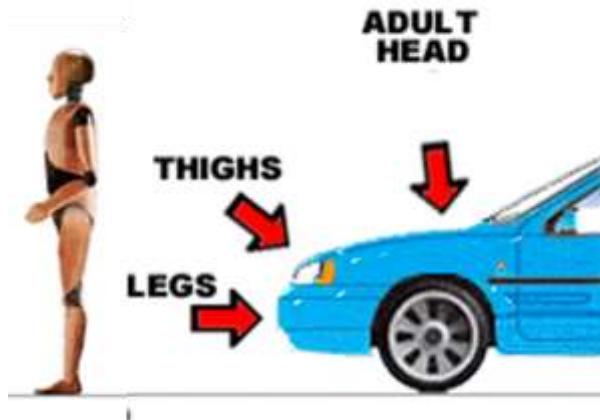
Figure 2: General view of vehicle-pedestrian impact points

- The available injuries on the body of the deceased correspond well to those arising from a car impact on a pedestrian on the back surface of the body with characteristically located injuries in the form of deep bruises, without abrasions of the skin in the lower extremities, which can occur from elements of the bumper or the protruding part of the hood of a car. The hemorrhage to the lumbar region with abrasion may arise from an already deformed element of the hood of the car. In this impact, the lower limbs correspond to have been in a basic support position on the ground in order to obtain the available damage to the soles of the boots. The lack of stains on the exposed parts of the tears indicates that they occurred in the accident. In such an impact within the center of gravity and the lower limbs, the energy of the vehicle is given to this part of the body as the upper part lags behind, especially the area of the neck where the bending occurs. In

this case there are reliable morphological data for abrupt tilting of the head backwards and overstretching of the cervical spine. These injuries can be attributed to the so-called characteristic injuries in case of a pedestrian-vehicle collision in the complex of direct and indirect impact. The hit in the area of the head was performed in the right parieto-occipital part, where no abrasions were found on the surface of the skin in the limited area of the impact, compared to the general circular configuration of the skull. This indicates an impact on an object with a wide contact surface, with simultaneous damage to the brain structures of the type of "Contra coop" and a deformation of the skull in the event of the fracture of the skull base when the head reached and broke the windshield.

The comparison of the described deformations of the car, the traumatic injuries on the body of the victim and the corresponding mechanogenesis of occurrence, compared in the general complex of the traffic accident, determines the more probable mechanism of impact between the pedestrian and the car. The established cervical trauma, examined in its entire complex and compared with the age of the victim, pointed to a more significant speed of the car of approximately 70-80 km/h. No injuries were found that could correspond to an impact of any anatomical parts of the horse pulling the wooden cart.
