## A CASE OF SEVERE THERMAL AND CHEMICAL BURN CAUSED BY AIRBAG DEPLOYMENT

**Key words:** airbag, full thickness burn, wrist combustion

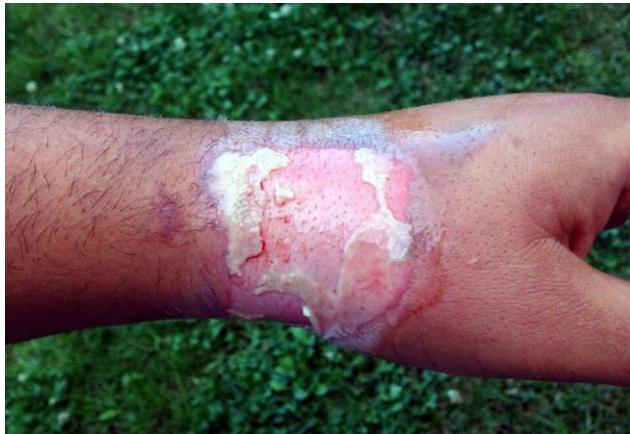
**Pic. 1**

In order to escape a hurdle a driver lost control over his automobile and hit frontally a tree next to the roadway. By driver's testimony, the speed of the automobile at the moment of impact was about 40km/h. The steering wheel airbag opened due to the crush. The driver was with his seatbelt on. Right after the accident, the driver saw that his left wrist was edematous and inflamed, with formation of blisters. The medical examination established 3<sup>rd</sup> degree burning in the area. The specialized therapy continued for a month. During that month the status of the patient was studied by our team and more burnings of 2<sup>nd</sup> degree on the right forearm and the front right surface of the neck were observed. Pictures №1 and №2 show the burnings of the left wrist two hours after the accident. The maceration of the epidermis is a result of necrosis due to the action of the hydroxyl anion.

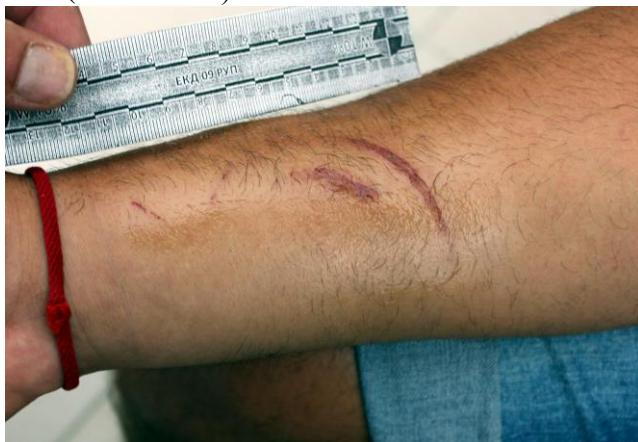
**Pic. 3**

Edema in depth of the soft tissues was also seen. The borders of the injury were well limited. The morphology of the injury showed circular features. Its surface was approximately 65% of the circumference of the limb, as it was found in the areas of contact with the airbag. The first forensic medical examination of the patient was performed two days after the accident. There was an antiseptic bandage over the injury, which was not removed due to medical consideration. During the examination a specific burning of 2<sup>nd</sup> degree over the front surface of the lower part of the right forearm was observed. The burning was an unique specific imprint from the emblem of the automobile, situated over the decorative cap of the air bag module of the steering wheel (Picture №3). There was also spot-like burning of 1<sup>st</sup>-2<sup>nd</sup> degree over the left-front surface of the neck(Picture №4).

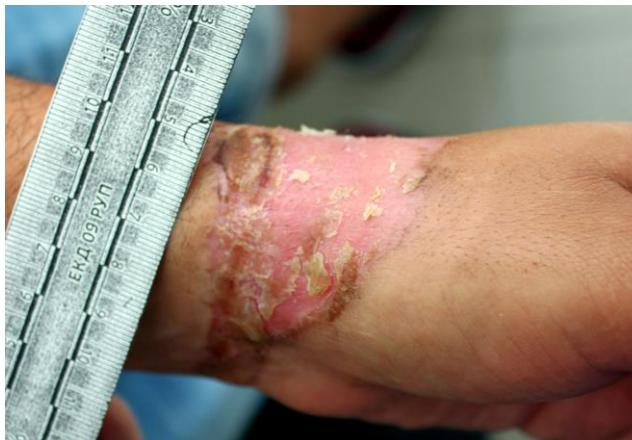
**Pic. 5**

The recoveries of both burnings were corresponding with the timing maintained by the victim. Ten days after the accident second examination was performed. The burning of the right forearm was healing, with crusts falling off. On the left-front surface of the neck there was increased pigmentation as a result of the healing process. The 3<sup>rd</sup> degree burning of the left wrist, correspondingly to the time that had passed and the subsequent treatment, was healing properly too (Pictures №№5, 6). The pictures show the remains of necrotizing epidermis, which falls off as crusts and reveals the fresh new granulation tissue. In the borders of the injury, where the burning was 2<sup>nd</sup> degree there is increased pigmentation.
